A VIEW FROM THE PENTHOUSE: USEFUL INFORMATION FOR THE WORLD OF BOILERS**DENTS AND DINGS**

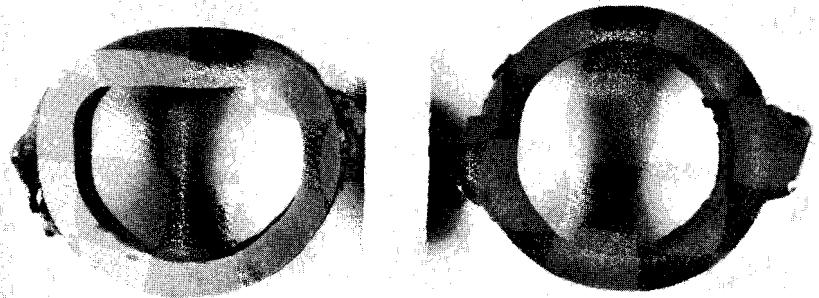
Figures 1, 2 and 3 show typical dents. The photographs are cross-sectional views taken through the minimum diameter of the dent. Fig. 1 is from a damaged roof tube dented by the rupture of a superheater tube in the vicinity. Fig. 2 is a cross section through a reheater tube dented by a shotgun pellet used for de-slagging. Fig. 3 is a dent caused by an improper lift during installation. For

Fig. 1. Roof tube damaged by flailing tube.

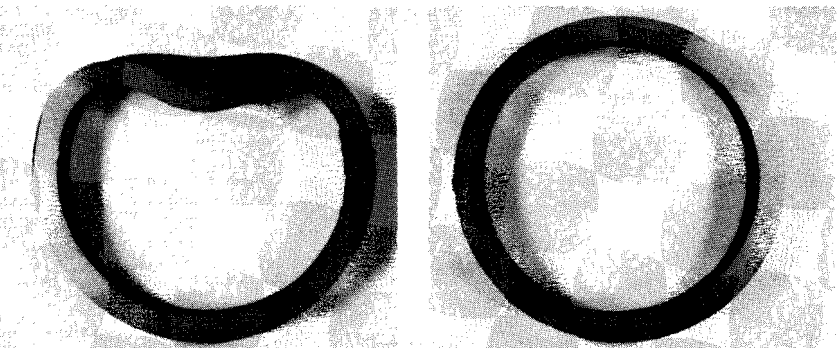
Fig. 2. Shotgun pellet damage.

The shapes of the paper cut-outs accurately reflect the cross sectional areas at the end of the tube and through the dent. These two cut-outs are weighed to 4 decimal places. The relative weights give the relative areas of the two paper cut-outs. By this technique the dents were shown to reduce the steam-flow area by 4-13%. The dented tube from the improper lift, Fig. 3, has an area reduction of less than 4%. The damaged roof tube from a guillotine rupture of a superheater tube, which then hammered the roof tube, had an area-reduction of 7 1/2%; and the shotgun-pellet dent, Fig. 2, has the largest area reduction, 13%.

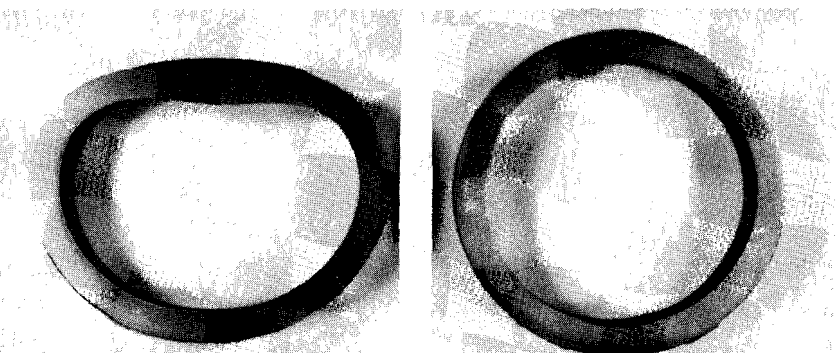
Fig. 3. Dent from improper lift.
