A VIEW FROM THE PENTHOUSE: USEFUL INFORMATION FOR THE WORLD OF BOILERS

HYDROGEN DAMAGE - AGAIN

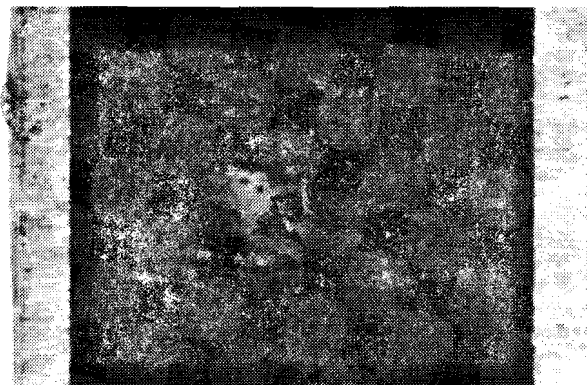
Figure 1.

Hydrogen damage usually occurs under localized and thick water-side deposits. Figure 1 is such an example.

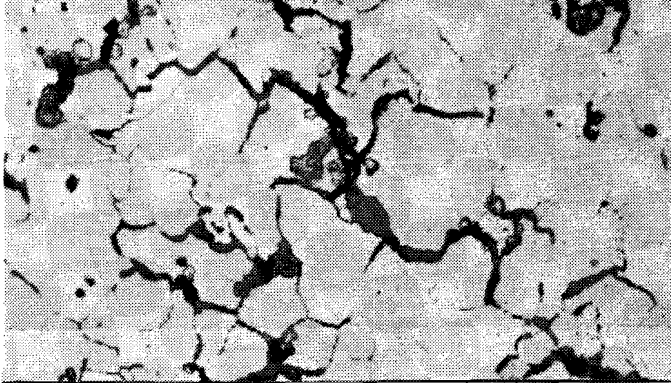
Hydrogen-damaged microstructures always contain intergranular cracking and often substantial decarburization to the point where there may be no pearlite remaining within the structure, see Figure 2. Depending on the age of the damage, the intergranular cracking that is almost always connected to the ID surface will contain (and be filled with) iron oxide as a result of the

reaction of the crack surface with boiler water. This is the same reaction that forms the protective iron-oxide scale throughout the entire boiler.

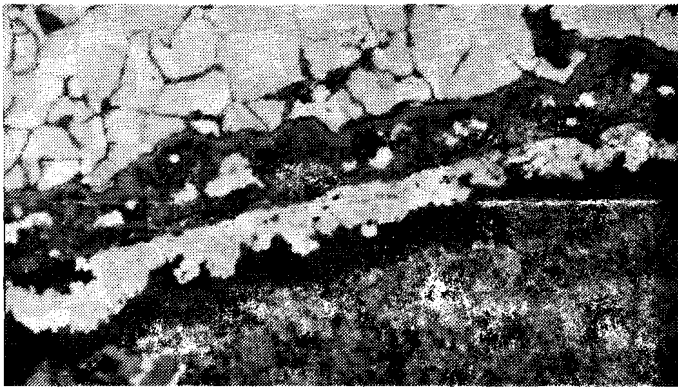
Figure 3.

One possible explanation for the initiation of scab-like, localized deposits is the incomplete removal of both copper and oxide deposits during chemical cleaning. Figure 3 shows an ID deposit with several alternating layers of copper and oxide. In order to remove both oxides and copper, a two-stage chemical cleaning is required, one stage to remove the iron oxide and a second stage to remove the copper. However, if there are multiple layers of copper, then this two-stage cleaning cycle needs to be repeated. Once a deposit has formed, and the chemical cleaning has not totally removed the entire deposit, the scab-like final deposit has a start. Subsequent chemical cleanings do not have time to remove a still thicker deposit.

In light of these delayed failures, a more thorough chemical cleaning may be necessary to completely remove all of the localized water-side deposits. To assure complete cleaning, a borescopic examination or sample removal for visual inspection may be necessary. In the final analysis, hydrogen-damaged tubes may have to be completely replaced; as there is no known method for repair of hydrogen-damaged tubes except to replace them.
