A VIEW FROM THE PENTHOUSE: USEFUL INFORMATION FOR THE WORLD OF BOILERS**UNUSUAL CORROSION FAILURES**

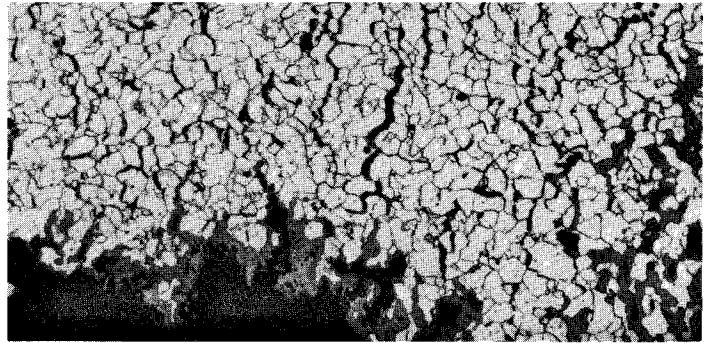
Figure 1. 200x

Figure 1 shows a characteristic microstructure of hydrogen damage. Hydrogen damage occurs in waterwall tubes under thick, waterside corrosion deposits. One of the products of corrosion is atomic hydrogen which, being a small atom, diffuses into the steel. Hydrogen reacts with iron carbide to form ferrite and methane. The methane molecule is large and cannot diffuse through the steel; so collects at the ferrite grain boundaries. When the methane pressure is sufficiently great, intergranular cracks form along the ferrite grain boundaries.

There are two characteristic features to hydrogen damage. 1) intergranular cracks, and 2) loss of iron carbides (decarburation). Figure 1 shows both of these characteristics. The cracks are quite long, extending over many grains and some are oxide covered with corrosion products.

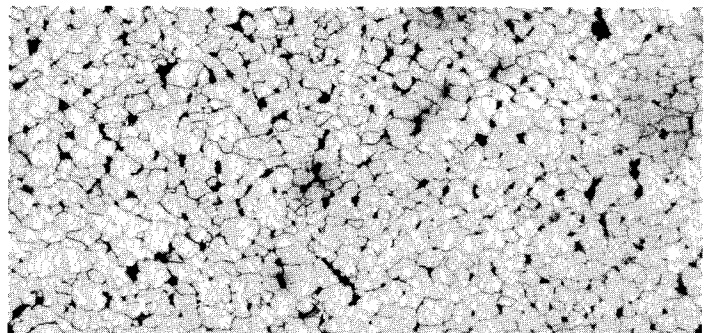
Figure 2. 200x

Figure 2, from the same boiler, shows the second effect of thick waterside deposits, that is, elevated temperatures and creep damage. The microstructure shows intergranular creep damage, or creep voids, not hydrogen damage. Here the voids appear to be no longer than a single crystal boundary and are more hole than extended crack. The microstructure along the ID surface of the tube at this location shows no intergranular cracking to the ferrite grains. For waterwall tubes, creep failures usually start at the OD surface as the metal temperature is 75°-100°F hotter than at the ID. Thus, this particular failure is an elevated-temperature stress rupture caused by the waterside deposits.

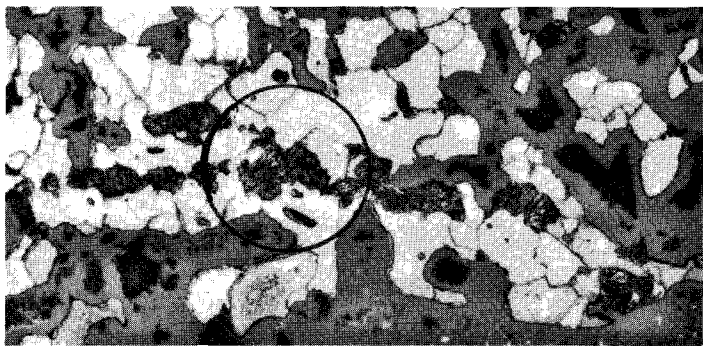
Figure 3. 500x

Figure 3 shows intergranular corrosion of a carbon steel waterwall tube. Here the corrosion attack has proceeded selectively along the ferrite grain boundaries. That this is not hydrogen damage may be seen from the fact that pearlite colonies are still intact within the region of intergranular corrosion (note encircled zone). Since this damage was noted at the bottom of a fairly large pit suggests the corrosion is by oxygen attack, rather than by a pH excursion.

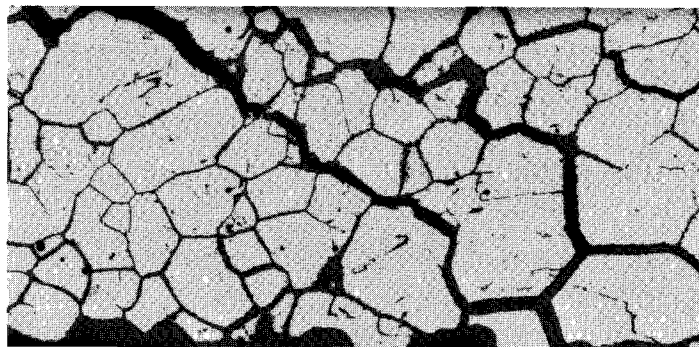
Figure 4. 100x

Figure 4 shows grain-boundary corrosion of a 304 stainless superheater tube. At temperatures above about 1050°F, chromium carbides form along the austenite grain boundaries. The formation of these carbides depletes the austenite grains of chromium adjacent to the grain boundaries. As the chromium content decreases below about 12%, the corrosion resistance is severely impaired. This structure is said to be "sensitized." In effect, the austenite grain boundaries are no longer stainless steel, and corrosion proceeds rapidly. The net effect is the attack along the austenite grain boundaries, as shown in Figure 4.
