A VIEW FROM THE PENTHOUSE: USEFUL INFORMATION FOR THE WORLD OF BOILERS

DEW POINT CORROSION

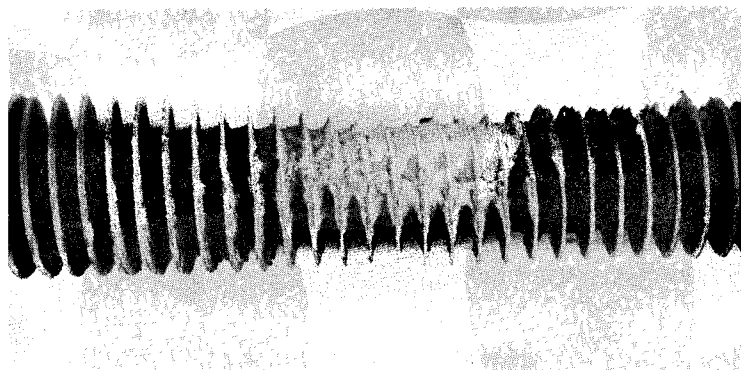
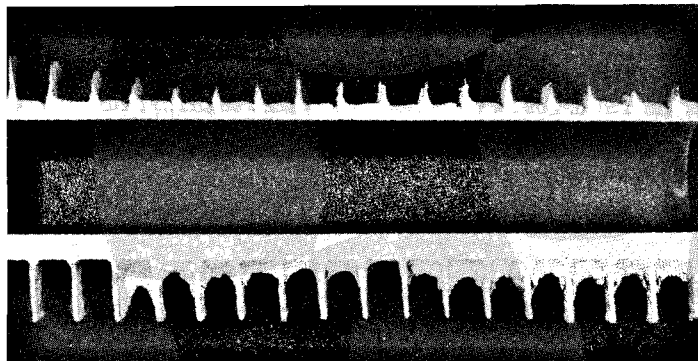
Dew-point corrosion is exacerbated in coal-fired boilers by the presence of fly ash. Fly ash accumulates throughout the flue-gas path and the resultant fly-ash deposit acts like a sponge to collect both moisture and acid especially during shutdown cycles. Figures 1 and 2 present a finned-tube economizer that has suffered severe wastage due to dew-point corrosion. Figure 1 shows the loss of the fins and Figure 2 documents the wastage of the tube itself. Compare the tube-wall thicknesses on opposite sides of the tube. Fly ash remains between the fins to trap sulfuric acid. Acid smuts occur when the gas temperature is less than the dew point and H_2SO_4 forms on fly ash particles.

The fly ash-sulfuric acid corrodes the steel in two ways: (1) the normal sulfuric acid corrosion of steel and (2) crevice corrosion which causes differential aeration and/or concentration cells that leads to a localized pitting attack. Thus the corrosion rate under the fly ash can be considerably faster than simple dew-point corrosion alone.

In summary, the easiest way to prevent dew-point corrosion problems is to take care of the housekeeping to prevent air in-leakage. Keep metal temperatures about 300°F.
