## View From the Penthouse Winter 2012

### Signs of Aging in Old Boilers

## Signs of Aging in Old Boilers (continued)

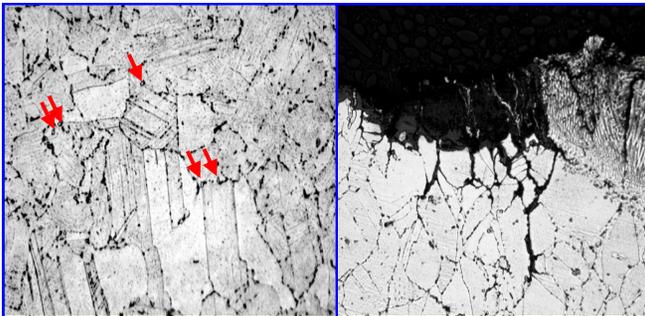
and sigma phase, refer to **Figure 5**. The appearance of sigma phase suggests this pendant or end of several pendants may have operated above the design temperature of a fair portion of the 33 year service. It may also imply a U shape to the temperature distribution within the superheater (other pendants have to be examined to confirm). At the OD next to the weld metal and HAZ, are the expected inter-

**Figure 5** - The microstructure of the 321H is austenite, as expected. The grain boundaries are well covered with both carbides (sensitized) and sigma phase, the large black spots on the grain boundaries. 400x, etched

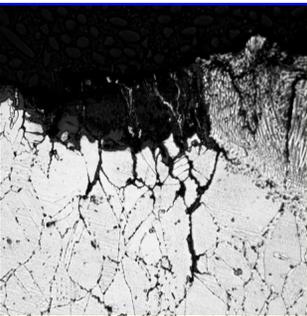
**Figure 6** - The OD at the toe of the DMW contains the early stages of creep or creep-fatigue damage, the intergranular cracks. 200x, etched.

granular creep or creep-fatigue cracks, Figure 6, the result of the combined tensile stresses (from bending and the DMW). Also noted near the cracks are twin boundaries, the straight black lines across some austenite grains, evidence of plastic strain from the tensile stresses.

A small step or change in diameter, a stress raiser or “notch”, at the edge of the weld metal. The 321H oxidizes more rapidly than the nickel weld metal (similar in composition to Inconel 625). Over the service life, the stress raiser further increases the effective tensile stress.

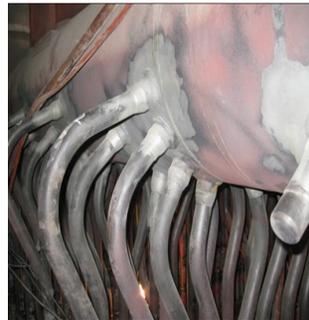
**Figure 1** - Photo of the new end row of tubes, grit blasted for ease of examination. The last pendant was removed at start-up to balance steam temperature and the capped tube at the right is part of the modification.

Inspection of the high temperature SH outlet header found significant cracks at the inner tubes of an eight-tube array, see **Figure 1**. A close-up view of the damaged region is presented in **Figure 2**; note the crack removal areas are in the smaller diameter tube and are on the half toward the end of the header. The deflection of the tube from differential expansion would put the tension portion of the tube facing

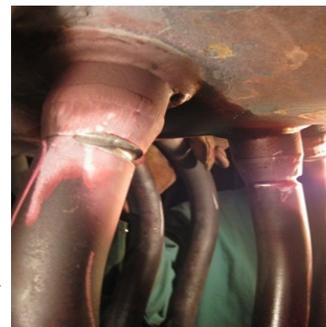
**Figure 2** - Close up of the crack removal area since the crack was ground away prior to repair welding at the 321H HAZ.

In the present example the failure is in the 321H. Since the tensile stresses are additive, the stress from bending of the stub tube (from differences in expansion between roof and header) adds to the stress in the HAZ (from differences in expansion between 321H and the weld metal). The result is failure in the smaller diameter 321H tube as noted in **Figure 2**.

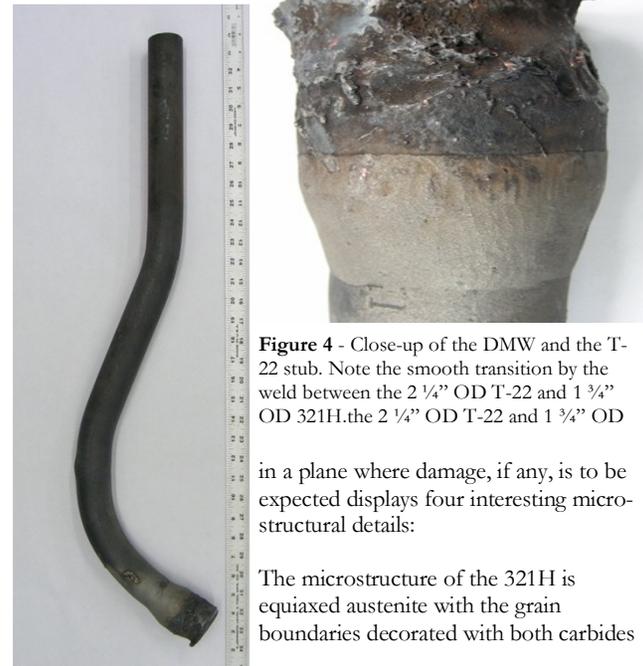
A second row stub tube was sent to DNFM for metallurgical analysis and is shown in **Figure 3**. A close-up is presented in **Figure 4**. The DMW is well-made with a smooth transition between the tubes of differing diameters. Metallographic analysis of the DMW

**Figure 4** - Close-up of the DMW and the T-22 stub. Note the smooth transition by the weld between the  $2 \frac{1}{4}$ " OD T-22 and  $1 \frac{3}{4}$ " OD 321H. The  $2 \frac{1}{4}$ " OD T-22 and  $1 \frac{3}{4}$ " OD
