A VIEW FROM THE PENTHOUSE: USEFUL INFORMATION FOR THE WORLD OF BOILERS

Creep Failures

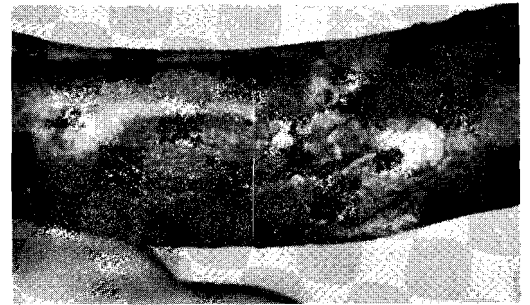
Creep failures may be caused by overheating the entire tube, or a very localized area. Figure 1 shows a typical creep failure. Note the narrow fissure and lack of ductility.

Fig. 1. Failed RH tube, T-22.

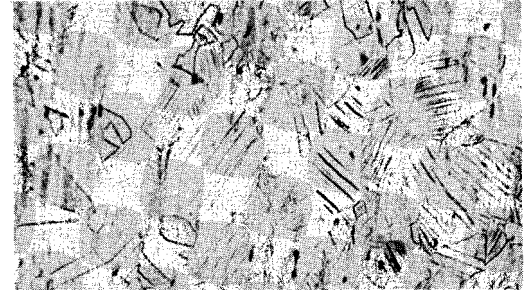
- 1) Up to about 15% elongation, there is little change in the microstructure (at 500x).
- 2) From about 15% to 20%, slip lines appear within individual crystals within the structure, see Figure 2.
- 3) At deformation greater than 20%, individual grains will begin to show (at 500x) elongation; nearly round grains become oval.
- 4) The hardness increases and the material is said to have "work hardened". All of this plastic flow makes the material harder.  $R_B$  hardness might increase from 70 to 85 or 90, depending on the material and amount of strain.

Fig. 2. 20% deformation in 304H, 500x.

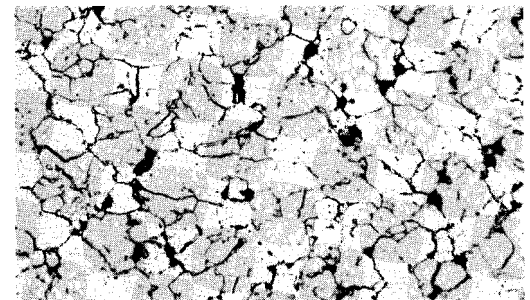
Since creep occurs at elevated temperatures, there are other changes in the microstructure. For ferritic steels (SA-210, T-11, T-22, etc.) the appearance of the iron carbide phase or pearlite is altered. In new material iron carbide is in the form of blades or platelets. At elevated temperatures these blades become spherical and the material is said to have spheroidized. Thus the microstructure of a sample that has failed by creep, will contain both spherical carbide particles and creep voids.

Fig. 3. Creep voids & spheroidization, T-22. 500x.

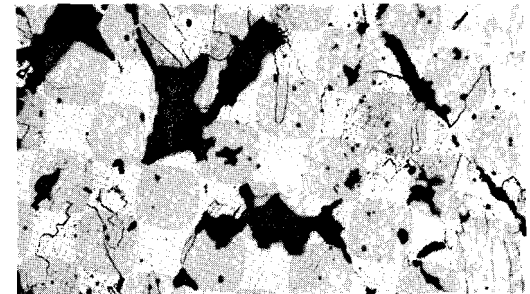
For the stainless steels (304, 321, 347) there is no pearlite and the carbide phase appears as tiny particles along the grain boundaries. The microstructure of these alloys will show voids or grain boundary separation. Figures 3 and 4 show these changes in the microstructural appearance.

Fig. 4. Creep voids, 304H, 500x.
