The DNFM Technical News Letter

David N. French Metallurgists

A Closer Look at PRB Coal

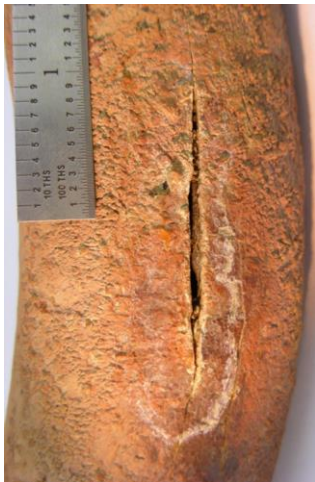
Slagging may be elevated in the high temperature superheater/reheater areas due to higher furnace gas exit temperature, **Fig. 1**. This situation is further exacerbated by low-NO_x burners and over-fired air (OFA). **Figures 2 and 3** illustrate the coal ash corrosion on a reheater tube after switching to PRB coal. Using blends of high-chlorine and PRB coals also promotes

Figure 1. Thick slag build-up on a reheater tube after switching to PRB coal.

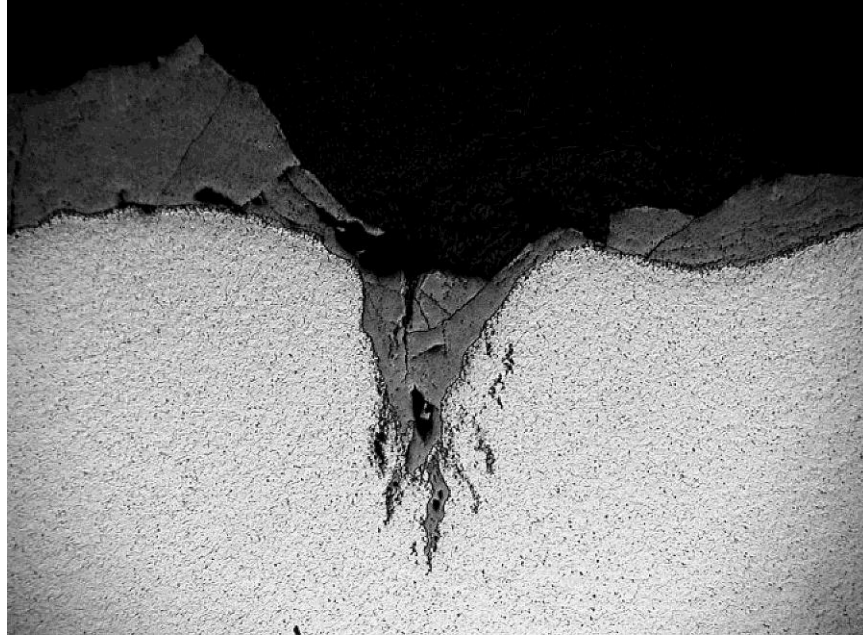
Figure 2. Tube wastage and creep damage, reheater T22 tube, OD. 80x.

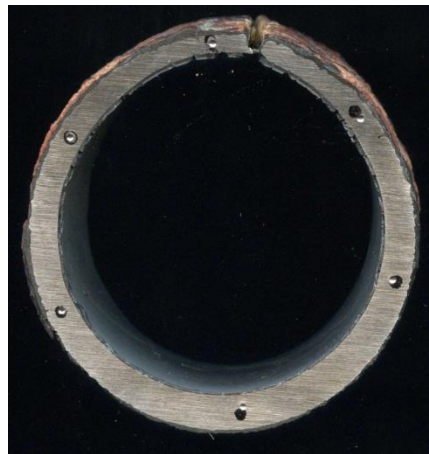
Figure 3. Ring section from the tube in **Fig. 1**. Note the severe wastage at the 12:00 orientation of the tube due to coal ash corrosion.
