A View from the Penthouse

The DNFM Technical News Letter

Effects of Chlorine and Cold Working on Stainless Steel Tubes

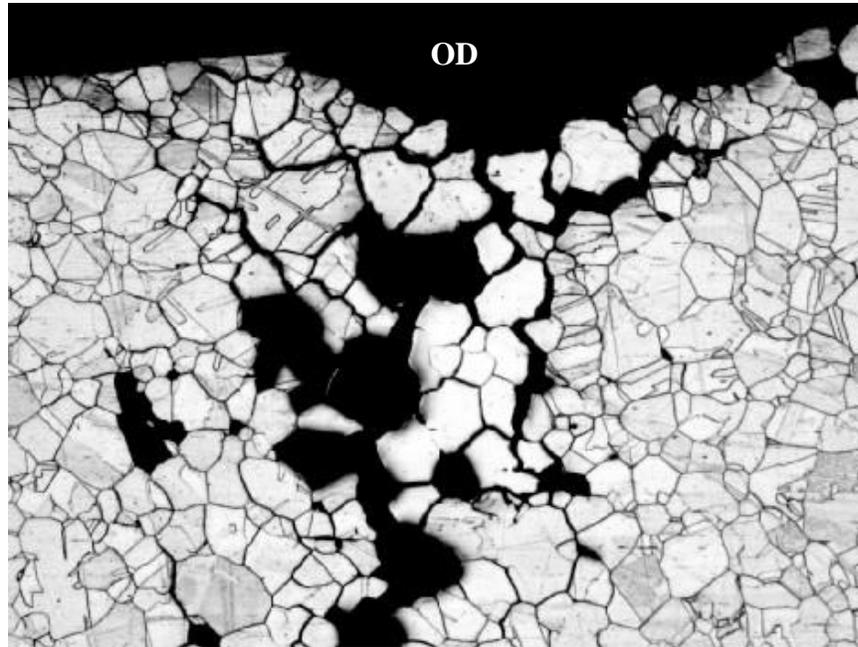
SCC can be intergranular (along the grain boundaries), transgranular (across the grains) or both, depending on the operating conditions. Since they resemble each other, intergranular SCC failures in high-temperature superheater/reheater tubes should not be confused with creep failures. With creep failures, intergranular creep voids are present at higher magnification; this is not so with intergranular SCC. Another clue is that intergranular SCC typically exhibits missing grains from the affected area after polishing. When superheater/reheater tubes in a high-chlorine fuel environment are water washed, the chlorides dissolve in the water, run down the pendants, and collect at the bottom. Residual stresses from the cold work during tube bending and/or unintentional stresses from sagging or defective support system/restraints may initiate SCC failures. **Figure 1** illustrates OD-initiated SCC in a reheater tube. Corrosive species were from offline water washing and stresses were from residual stresses due to cold work during tube bending. SCC is also a concern at the ID of austenitic high-temperature superheater/reheater tubes. The contributing sources can be carryover of volatile chemicals from the boiler, contamination from chemical cleaning, and/or upstream attemperator sprays to control the steam temperatures. In **Figure 2**, some grains seem to have fallen out during polishing, typical for intergranular SCC.

Figure 1. Intergranular SCC and missing grains, OD. 87x

Drum levels and the condition of attemperator sprays should be checked periodically to reduce contamination. Higher drum levels may cause corrosive species to enter the high-temperature superheaters. Attemperators should spray high-quality, chlorine-free mist, and not spray water like a fire hose, which often results in thermal fatigue cracking at the ID surface. Periodic visual inspections are required to eliminate unintentional loading due to sagging, restraints or defective support systems. ASME PG-19 indicates austenitic tubes shall be heat treated if the forming strain is 10% or more, dependent on the tube design temperature, to reduce the risk associated with SCC and SIPH in the high temperature environment.

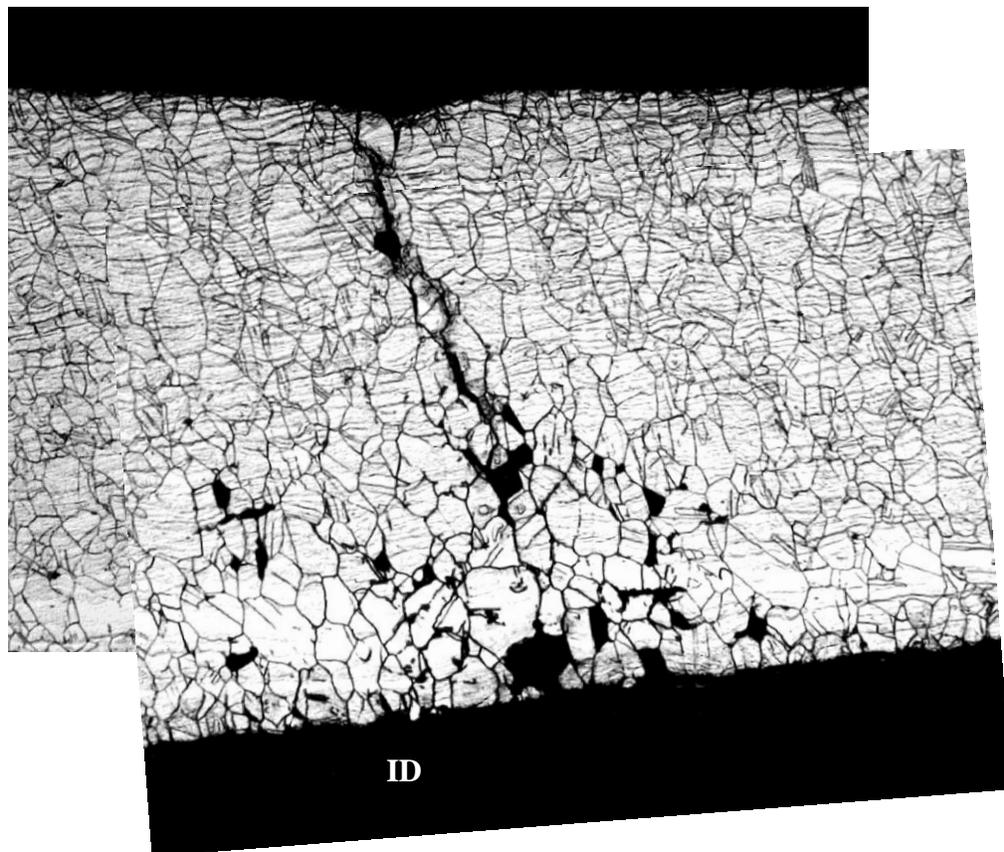
Figure 2. Intergranular SCC, black voids where grains were removed, ID-initiated SCC. 50x.

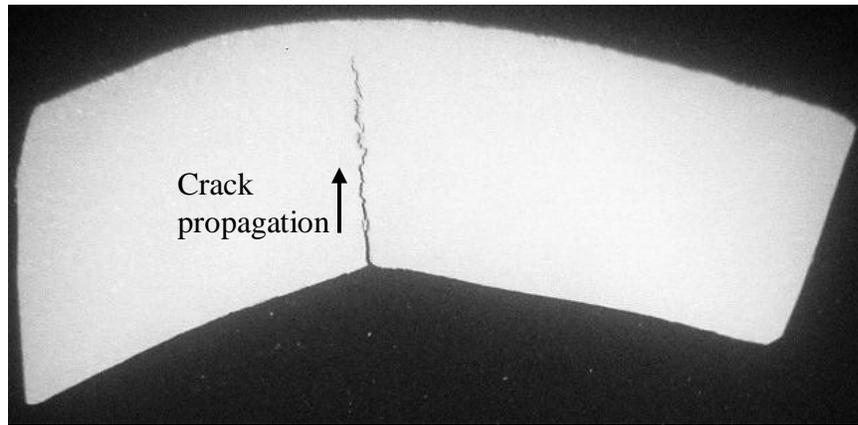
Another problem associated with cold-working (bending and swaging) of austenitic stainless steel tubes during fabrication is that this can lead to premature failure when the tube operates within the creep range. Cold-forming, such as bending and swaging of austenitic stainless steels during fabrication, can lead to premature failures when tubes operate within creep range. The reduced ductility due to precipitation is known as strain-induced precipitation hardening (SIPH). During cold-work, the alloying elements such as Cb/Nb, Ti and N precipitate at the grain boundaries, resulting in reduced ductility. The cold work of these materials increases both the strength and hardness, but reduces the ductility. At low temperatures, the reduced ductility is compensated by the improved strength/hardness. As operating temperatures rise into the creep regime, premature cracking in the cold-worked material may occur. These conditions are exacerbated by notches, attachments, and other stress-concentrating factors. SIPH adversely affects the creep ductility. In solution-treated materials when a grain-boundary creep crack develops, the growth or extension of the crack is slowed or blunted by the soft and ductile neighboring austenite grains. The deformation energy of the movement of the grain boundary crack is converted into plastic deformation in the crystals preceding the crack. In cold-worked material, the ability of the austenite grains to blunt the crack growth by energy absorption is diminished. Cold-worked grains are less ductile and can no longer "bend" to prevent further crack movement. Characteristics of these failures are intergranular cracking, no significant plastic deformation, deformation twins in the austenitic grains and no significant wall loss. **Figures 3** and **4** illustrate the fracture morphology of a SIPH failure. At a higher magnification of the crack tip in **Figure 5**, deformation twins can be seen. These are from cold work during tube bending.

Figure 3. Macroscopic view

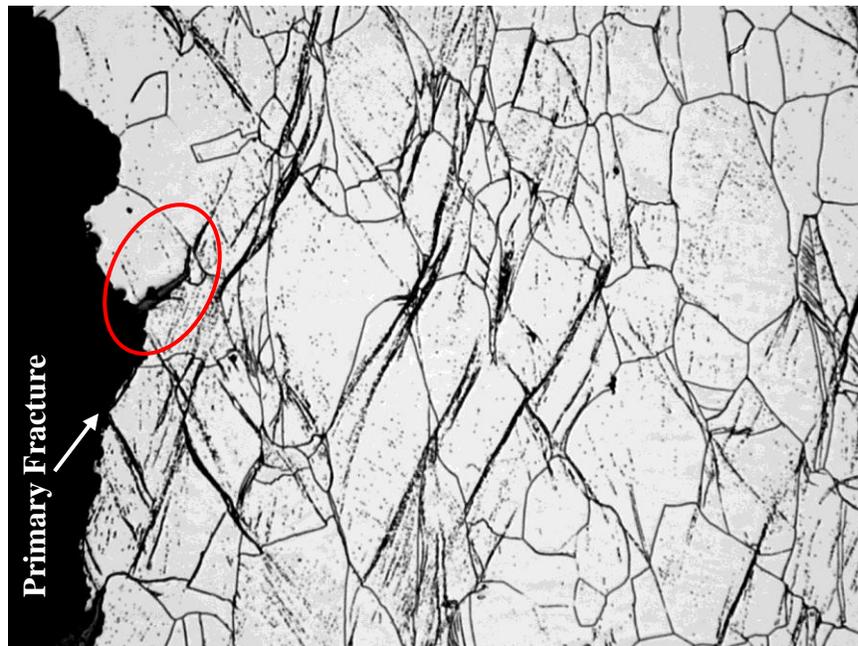
Figure 4. SIPH, primary fracture face, mid-wall. 200x.

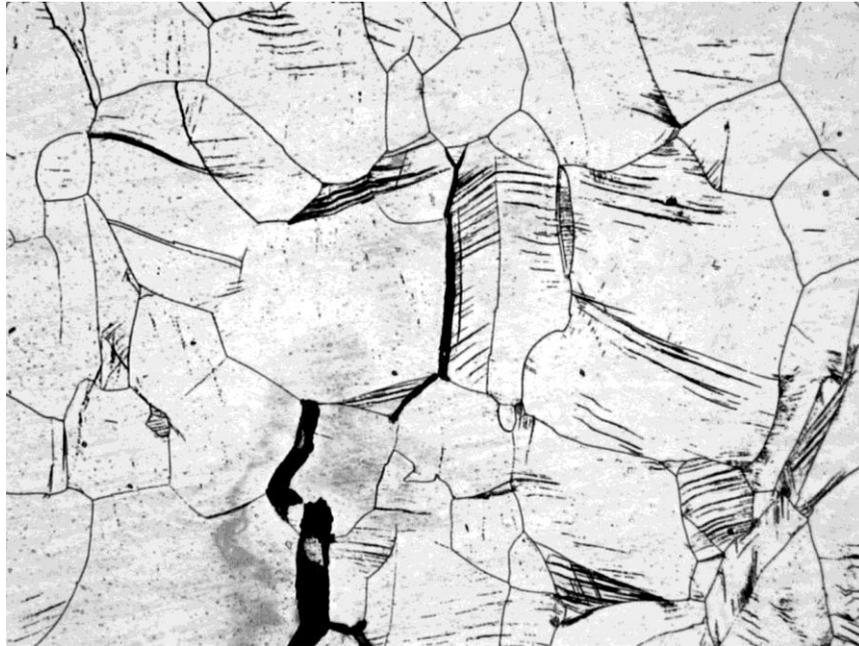
Figure 5. Deformation twins, crack tip. 400x.
