The DNFM Technical News Letter

David N. French Metallurgists

Understanding Fireside Corrosion

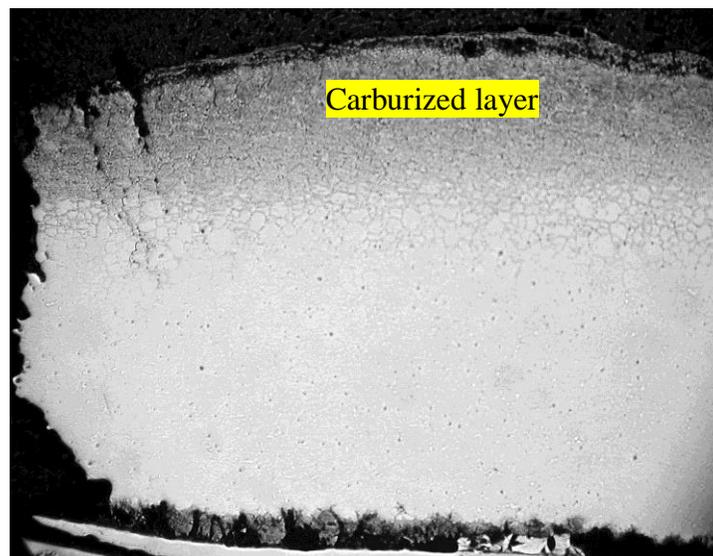
Fireside corrosion remains a leading cause of failure in superheater and reheater tubes. Tubes affected by the fireside corrosion mechanism may lose as much as 15 mpy and in extreme cases even higher corrosion rates have been observed. Fireside corrosion occurs via two modes. In the first mode of corrosion, tube wastage occurs by the formation of low melting species, which dissolve the protective iron oxides on carbon or low alloy (Cr-Mo) steels. In the second mode, the tube wastage occurs when there are reducing conditions inside the furnace, and iron sulfide scales form instead of protective oxides. These iron sulfide scales are more porous and less protective than oxides. Reducing conditions also promote carburization of Cr-Mo and stainless steels (**Fig. 1**), resulting in loss of corrosion resistance. Unburnt carbon and carbon monoxide are carriers of carbon to the steel surface under reducing conditions. Formation of chromium carbides along the austenite grain boundaries and within the surface grains reduces the corrosion resistance of stainless steel.

Figure 1. Carburization of stainless steel tube. 42x.

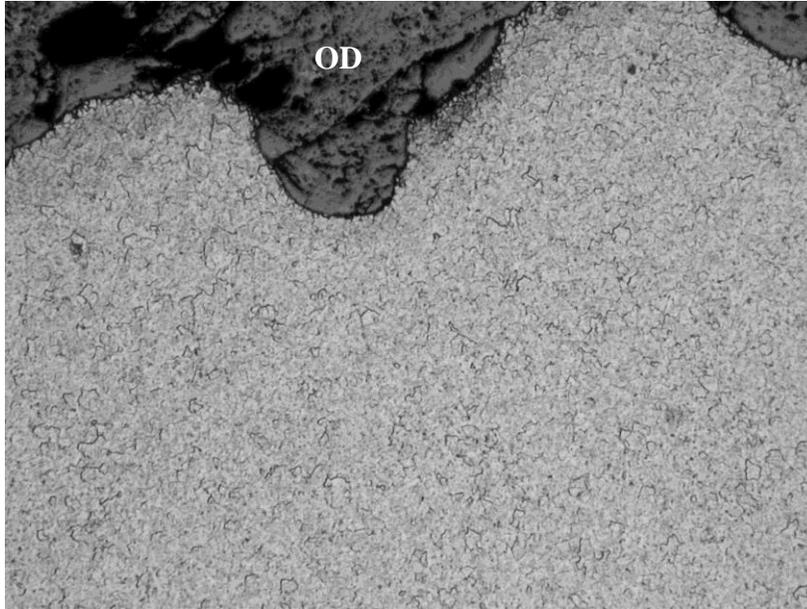
The corrosion rate is especially high in coal-fired units when the tubes are operating between 1100 and 1250°F. In this temperature range, complex liquid sulfates ($\text{Na}_3\text{Fe}(\text{SO}_4)_3$ or $\text{K}_3\text{Fe}(\text{SO}_4)_3$) form, resulting in rapid corrosion. **Figure 2** illustrates the view of coal ash corrosion that had occurred on the tube OD. **Figure 3** illustrates the ring section removed from a superheater tube. Note that wastage is on the flanks (arrows) of the tube, typical for hot ash corrosion. Above 1250°F, the corrosion rate is decreased significantly due to decomposition of these complex liquid trisulfates. Once the liquid phase has been removed, the corrosion is due to oxidation in contact with flue gas. The thickness of the oxide scale decreases during corrosion reactions and the metal oxidizes further to renew the oxide layer. The tube metal temperature decreases as slag thickens. At room temperature, low-melting compounds sinter the ash particles to form a tightly bound inner layer. After the slag thickness reaches equilibrium, deslagging increases because the liquid layer on the tube cannot support a thick layer of ash. This deslagging increases the tube-metal temperature. This process (slagging and deslagging) repeats in a cycle that leads to create the corrosion pattern known as ‘elephant hiding’ or ‘alligator hiding’, as shown in **Fig. 4**.

Figure 2. View of coal ash corrosion, OD, 100x.

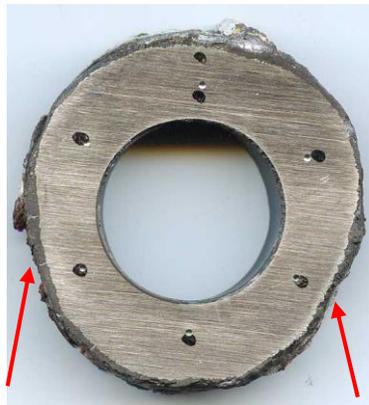
Figure 3. Sectioned ring from the tube with corroded areas noted.

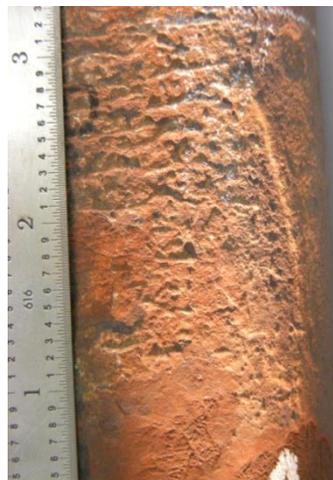
Figure 4. "Alligator hiding".

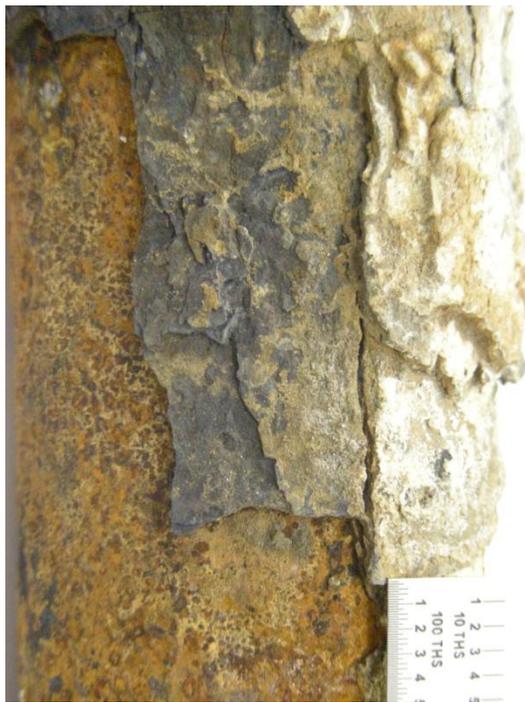
In refuse fired boilers, chloride and sulfate species lead to the formation, on the tube surface, of low melting species that may contain iron, zinc, lead, and sodium. These species dissolve the protective iron oxide and expose the bare steel to the corrosive environment, resulting in significant wall loss, as shown in **Fig. 5**. Reducing conditions inside the furnace may lead to the formation of iron sulfide instead of iron oxide. The presence of carbon and iron sulfide within the ash deposits indicates the presence of reducing conditions. Hydrogen chloride can more easily attack iron sulfides, rather than oxides, to form iron chloride as a corrosion product. This iron chloride has a relatively low boiling point, and therefore iron chloride vapors form in the superheater/reheater temperature range, and the corrosion mechanism is by loss of iron as a vapor. The porous sulfide formed in reducing conditions allows the easier formation and removal of iron chloride vapor. In **Fig. 6**, severe fireside corrosion led to creep damage in a relatively new superheater tube.

Figure 5. Thick OD deposit and severe wastage, refuse fired SH tube.

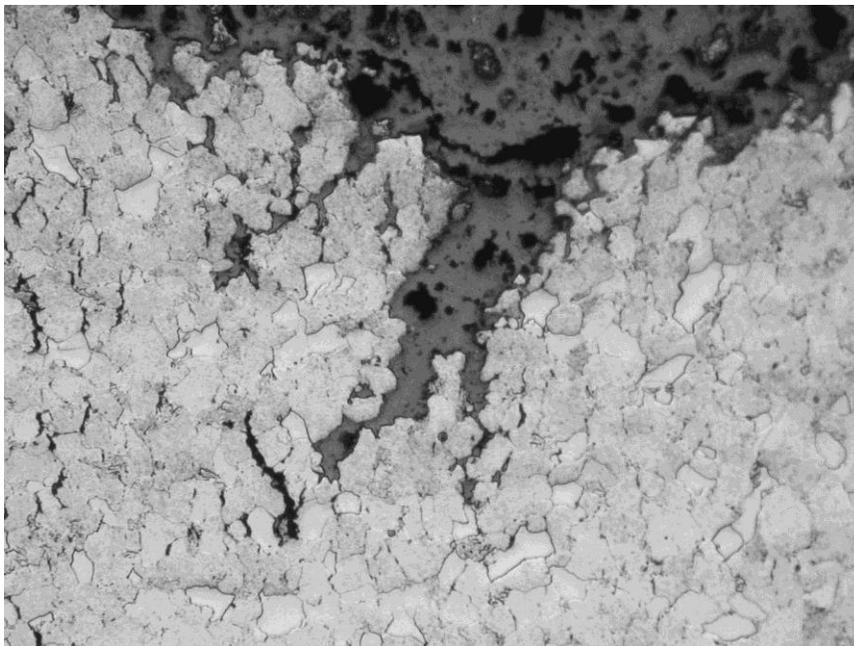
Figure 6. Creep damage due to severe wastage, OD, 200x.
