**A VIEW FROM THE PENTHOUSE: USEFUL INFORMATION FOR THE WORLD OF BOILERS**

**REHEAT CRACKING**

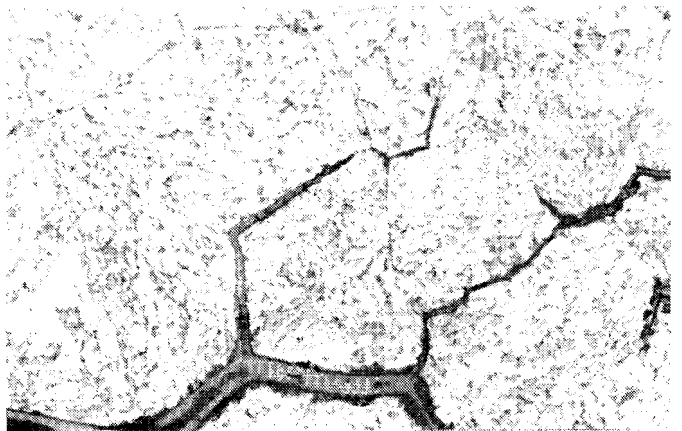
The simple explanation is that the brittle, martensitic heat-affected zone does not have sufficient ductility to absorb the release of residual strain and thus forms cracks to ease the strain.

The cracks follow the prior austenite grain boundaries, as these regions are the weak link. Figure 1 shows the crack morphology associated with reheat cracking. In order to prevent martensitic heat-affected zone formation, the cooling rate needs to be slowed down to allow the transformation from austenite to ferrite and iron carbide. The easiest way to achieve a slower cooling rate is by the use of preheat. Heat-affected zones that contain reheat cracks may have hardnesses in the Rockwell C 25-30 range or even higher, while heat-affected zones that do not crack have Rockwell B hardnesses in the 90-100 range. Ferrite and iron carbide are considerably softer than martensite, and the hardness of the heat-affected zone is one indication of the microstructural condition.

In summary, reheat cracks can most easily be avoided by use of adequate preheat that will assure a soft, more ductile, heat-affected zone within the T-11 and T-22 materials.
