A VIEW FROM THE PENTHOUSE: USEFUL INFORMATION FOR THE WORLD OF BOILERS**CREEP AND REMAINING LIFE**

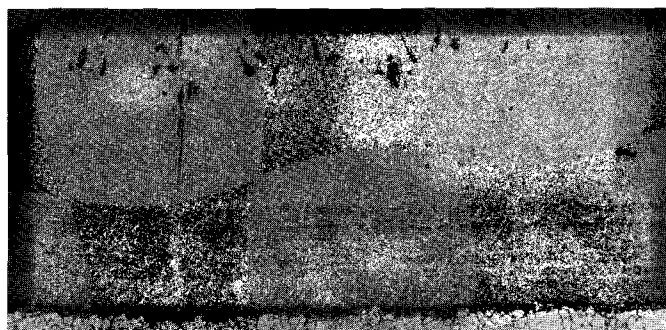
Figure 1

In any material-condition assessment, the most distressed tubes and highest heat-flux region should be examined first. Any single tube can show wide differences in metallurgical features. There are subtle changes within the microstructure that occur during the creep deformation process. However, the first sign of creep damage is often the appearance of longitudinal cracks within the steam-side scale, see Fig. 1.

Since the ductility of the steel is greater than the ductility of the steam-side magnetite layer, longitudinal cracks within this steam-side scale form as the oxide cannot expand with the steel.

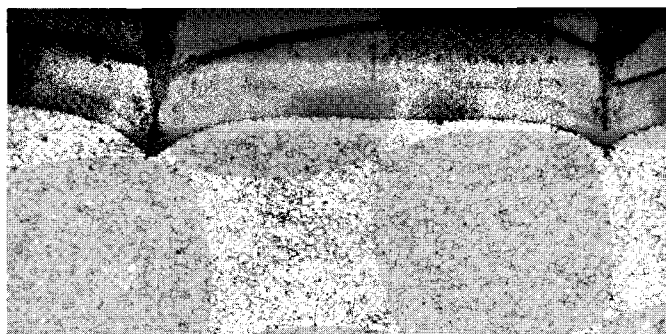
Figure 2

Once a longitudinal crack forms in the ID oxide, the path between steam and steel is shortened. With continued tube expansion due to creep deformation, the ID scale reforms at the crack. Locally a cusp forms at the scale/metal interface, see Fig. 2.

The sharp point acts as a stress raiser and intensifies the hoop stress at the cusp point. The stress is also slightly higher because the wall thickness is slightly less at the cusp. Depending on the circumstances on the fireside, similar longitudinal cracks may appear in the fireside scale. These OD cracks are more noticeable in gas-fired units, as fuel-ash corrosion may obscure these effects.

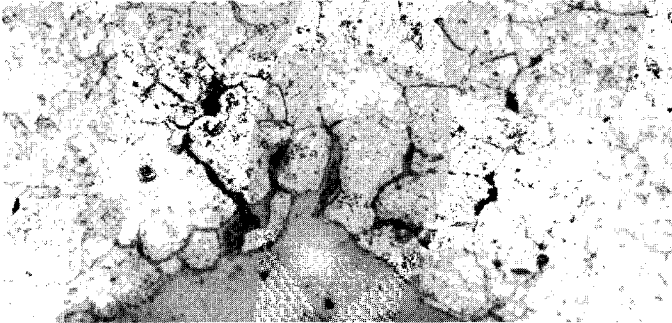
Figure 3

Often the first signs of creep damage within the steel microstructure are creep voids at these cusps, see Fig. 3.

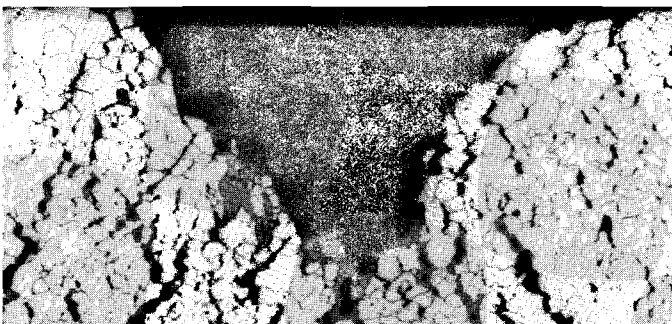
Figure 4

Less than 1/10 inch away from this damage, the microstructure shows no visible signs of distress. As the creep deformation continues, these OD and ID cracks and creep damage fan out toward each other, see Fig. 4. Creep failures may then initiate at the ID as the stress intensification at the cusp tip is a greater factor than the higher temperature at the OD surface.

Ultimately the effective cross section or thickness of the tube wall is reduced to the point where the strength of the material is inadequate to contain the internal steam pressure and failure occurs. The time between the appearance of the first longitudinal cracks within the ID scale and final failure is, of course, variable. It depends on the tube-metal operating temperature and whether there is any OD tube wastage from ash corrosion or fly-ash erosion. The time is quite sensitive to actual operating temperature. Heat flux will be variable along the length of an individual tube. Thus one portion of the tube may show well-advanced creep damage; while 20' away in the same tube, the microstructure shows no evidence of creep damage, not even longitudinal cracks in the ID scale.

Thus the estimation of remaining life and the determination of creep damage is sensitive to the location within the boiler. Samples for evaluation should be removed from the highest heat-flux regions of a superheater or reheater. If failures have occurred, samples from similar locations known to be "hot" should be included in the samples selected. Thermocouple measurement of steam temperature in individual tubes is helpful in evaluating the "hot" circuits. Steam-side scale-thickness measurements by ultra-sonic techniques that do not require the removal of tube samples may also be useful. However, to accurately assess the overall metallurgical condition, it is imperative to remove tube samples for careful metallurgical evaluation. Only by metallography can these steam-side scale cracks, cusps, and creep damage be accurately evaluated. Depending on the results, partial replacement of a few seriously degraded tubes rather than complete replacement may be the best course of action.
