Ph 502.955.9847 The DNFM Quarterly Newsletter DAVID N. FRENCH METALLURGISTS Fax 502 957 5441

## Under-Deposit Corrosion Issues in Boiler Tubes

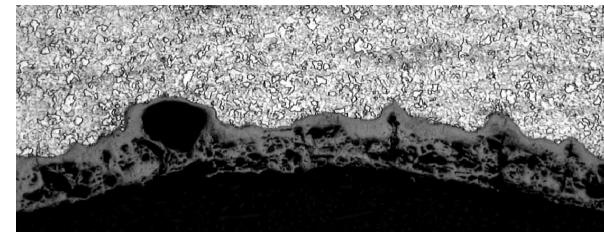
Water reacts with steel to form iron-oxide on the ID surface of the waterwall, and economizer tubes. Additionally, the particulate iron-oxide that formed elsewhere in the boiler, intentionally added feedwater chemicals, and feedwater corrosion products, will deposit on the tube ID surface. These deposits settle where gravity and flow disruptions (root pass of tube butt welds) are present. Also, the high heat flux zones (the burner elevation) are susceptible to form thick deposits. In water touched tubes, usually the inner thinner layer is dense due to reaction of steel and water as shown in **Fig. 1**, and the outer thicker layer is porous due to deposition of solid particles. Under-deposit corrosion (UDC) is often seen in roof tubes, the bottom of horizontal economizer tubes, and the top of the nose arch where significant deposits collect. Waterwall tubes in the high heat flux zones are also susceptible to UDC. As deposits develop, the tube temperature increases, as the thermal conductivity of the deposit is much less than the steel tube. The net result is higher metal temperatures, thicker deposits, and more rapid corrosion underneath.

**Figure 1.** Thin, dense iron-oxide inner layer and thick porous deposits. 100X

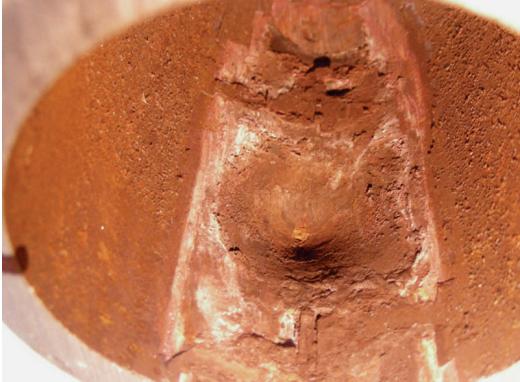
Significant tube wastage occurs underneath the thick deposits as shown in **Fig. 2**, due to UDC.

**Figure 2.**  
Tube bulge  
underneath  
the thick  
deposits

The thick deposits cause overheating of the tube resulting in bulges and creep deformation. Thick deposits along with the right corrosion environment may also promote hydrogen damage, acid phosphate corrosion, and caustic attack at the ID surface.

1. Periodically clean the boiler tubes to reduce the risk of UDC. Avoid the combination of oxygen and moisture when the unit is idle. Carefully dry the unit with the igniters before opening it to the atmosphere.
2. Investigate and prevent the source of contamination in case of thick deposit. Shutdown the unit immediately in case of contamination ingress.
3. Reduce flow disruptions in the tubes. For example, avoid using backing rings during butt welding.
4. Maintain equilibrium phosphate control. Use of mono or di-sodium phosphate should be avoided.
5. Monitor the high heat flux zones.
6. Feedwater chemistry should be under control in terms of caustic levels.
7. Keep the amount of particulate iron oxide as low as possible by blow-down to prevent build-up of thick scales.

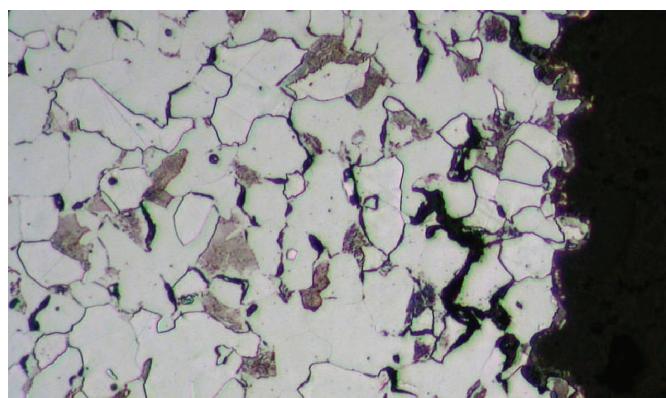
Hydrogen damage is the principle mode of waterside UDC. Hydrogen damage rarely occurs with little or no wall thinning, but in most cases, develops with significant wall wastage. Under acidic conditions, the hydrogen ion reacts with steel to form positively charged iron ion, and atomic hydrogen as shown in **Eq. 1**. Hydrogen damage is more prevalent in acidic environments, but it can also occur in strongly basic environments. Under basic conditions, the hydroxide ion reacts with iron to form iron ferroate ion, and atomic hydrogen, as shown in **Eq. 2**. The atomic hydrogen is trapped underneath the deposits and diffuses into the steel along the ferrite grain boundaries. Iron carbide in the steel reacts with diffused hydrogen to form a large molecule of methane as shown in **Eq. 3**. This large methane molecule cannot diffuse through the grain boundaries, so collects there and develops significant pressure leading to grain boundary cracks, **Fig. 3**, and eventually creates a thick-edge, low-ductility failure. Depending on the extent of damage, a complete decarburization may also occur in the microstructure. The end result is a microstructure that contains inter-granular cracks and is decarburized.

**Figure 3.** Hydrogen induced cracks and decarburization in the carbon steel. 400x

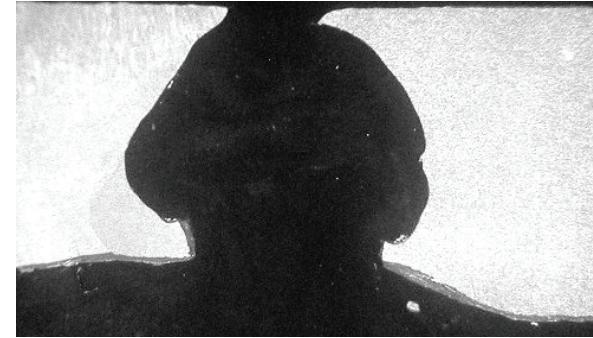
Acid phosphate corrosion is the second mode of waterside UDC. Phosphate corrosion occurs where thick deposits are present with the right combination of feedwater chemicals, localized flow disruption, or localized concentrating mechanism. The excessive addition of mono or di-sodium phosphates in the water treatment chemicals leads to phosphate corrosion, as shown in **Eq. 4-6**. The corrosion product will be white or grey marcite ( $\text{NaFePO}_4$ ). The addition of tri-sodium phosphates does not cause acid phosphate corrosion. This corrosion is localized where the phosphate hide-out occurs. The local environment is very acidic underneath the deposits, although the bulk water is within the acceptable limits. The affected area may be gouged with distinctive layers of deposit; the inner layer will be white or grey marcite, and on the outer layer reddish hematite may present. The gouged surface appears very smooth after removal of the deposits. The failure may be a pin-hole leak, **Fig. 4**, thick-edge crack, or ductile overload fracture with no micro structural changes.

**Figure 4.** Pin-hole failure. 5x
