View From the Penthouse Second Quarter 2007

Caustic Attack

CAUSTIC ATTACK

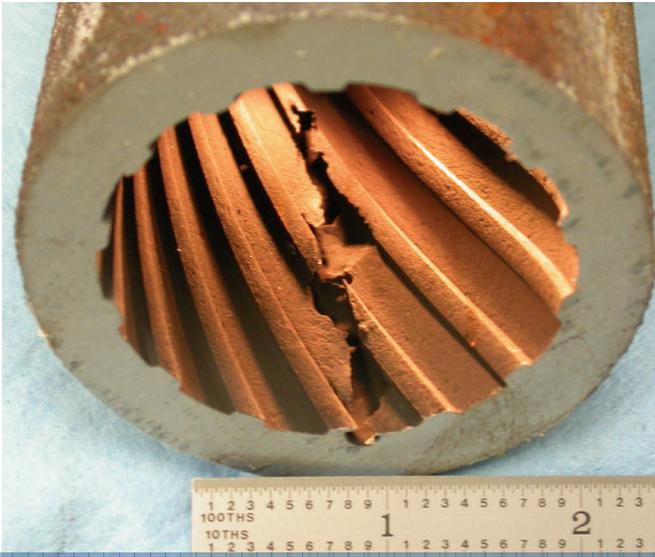
Caustic attack in a furnace division wall tube at a burner elevation

Caustic gouging results in shallow, usually hemispherical, depressions in the tube surface that are shiny and fairly smooth, sometimes with an undulating appearance. In the case of under-deposit attack by caustic, hard deposits are frequently present but often are washed off by the time the tube is removed for failure analysis. The deposits are layered, and may contain sodium ferroate or ferroite crystals. The failure will occur at an area thinned by corrosion, and the fracture edges will be thinned. No microstructural degradation is associated with this type of corrosion.

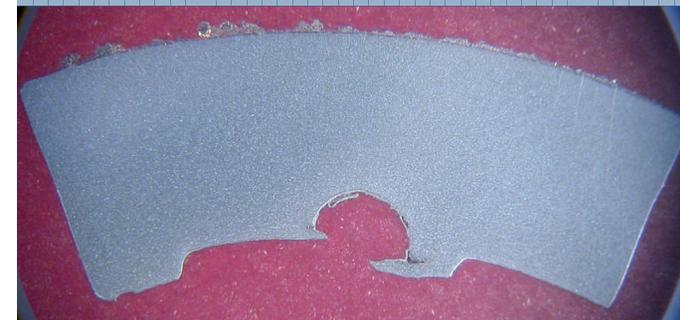
Cross-section of caustic attack
