View From the Penthouse SUMMER 2011

Issues Related to T-91/P-91 Steel

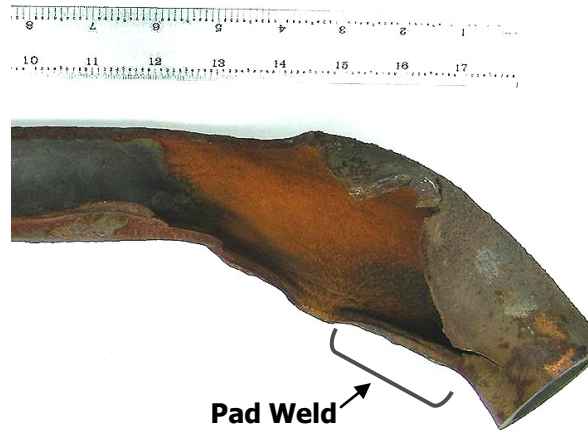
Figure 1 - Illustrates a failed T-91 tube which had been pad welded to repair erosion wastage. The failure occurred a short distance from the fusion line.

These failures are particularly difficult to repair because of the ASME Code requirement for both preheat and a 1350 °F PWHT.

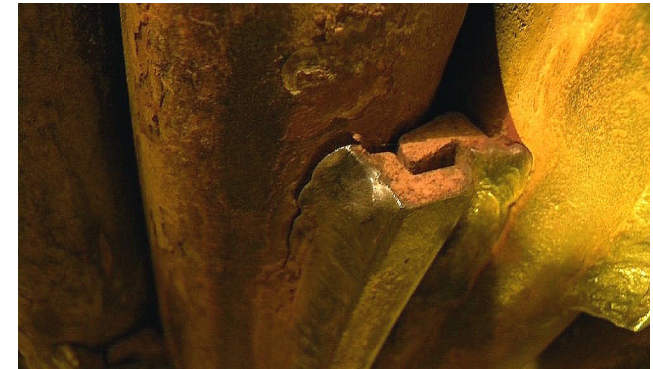
Other problems were noted on T-91 at welds between alignment clips and the tube.

Figure 3 - Refers to this problem providing an example of how the space between the clip and tube can become filled with oxide or ash, and the clip forced off the tube. **Figure 4** below is the micro where the oxide wedge acts as a stress raiser to separate the clip from the tube.
