WINTER 1998

A VIEW FROM THE PENTHOUSE: USEFUL INFORMATION FOR THE WORLD OF BOILERS

COLD FORMED AUSTENITIC STAINLESS STEELS

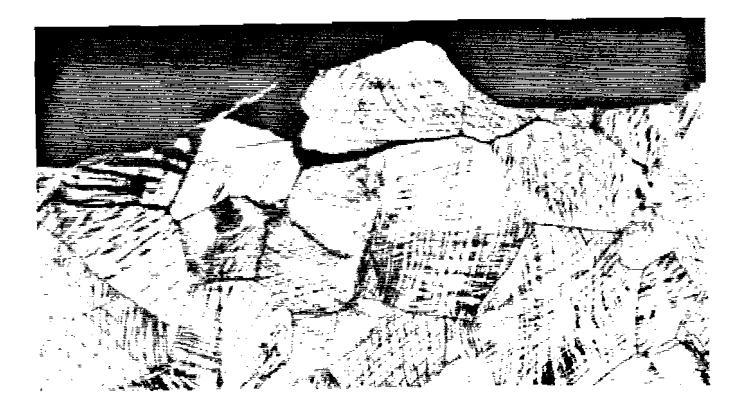
The failure is along the grain boundaries. Note the dark lines across the austenite grains, these are the deformation twins and are proof of cold work. This failure occurred after less than two weeks of operation. The Rockwell C hardness was 35. The SA213 specification limits the hardness for the 304H grade to 85 B. (Rockwell B 100 is approximately Rockwell C 20.) Thus, the hardness has increased by more than 30 Rockwell B hardness units. Failures from this phenomenon known as creep brittleness may be prevented by solution-treating after coldworking. The temperature for this heat-treatment depends on the alloy involved, but is about 2000°F. An appropriate guideline to use is that the post cold-forming heat-treatement temperature should be equal to the solution-treating temperature given in the material specification. For 304H, 321H, and 347H, reference is made to SA213 specification, and 304H should be solution-treated at 1900°F. 321H and 347H should be solution treated at 2000°F.

In solution-treated materials when a grain-boundary creep crack develops, the growth or extention of the crack is slowed or is blunted by the soft and ductile neighboring austenite grains. The deformation energy of the movement of the grainboundary crack is converted into plastic deformation in the crystals preceding the crack. In cold-worked material, the ability of the austenite grains to blunt the crack growth by energy absorption is diminished. Cold-worked grains are less ductile and can no longer "bend" to prevent further crack movement. The material is "creep brittle". This loss of creep ductility leads to failures that have the following characteristics: 1) Failure is always intergranular; 2) there is little gross distortion of the component; 3) the austenite grains will display evidence of cold work, deformation twins within the grains. (these twins appear as straight lines across the crystal); and 4) the wall thickness at the failure edge is virtually the same as elsewhere, that is, there is no obvious ductility. Figure 1 shows the fracture edge of a swaged 304H reheater tube.
